1. Introduction

The coating of profiled Fibre cement sheet roofing and Cladding in order to extend the waterproofing life of such structures has long been within the realms of the liquid roof waterproofing industry. This Guidance Note highlights some of the issues that need to be taken into consideration when undertaking this type of work.

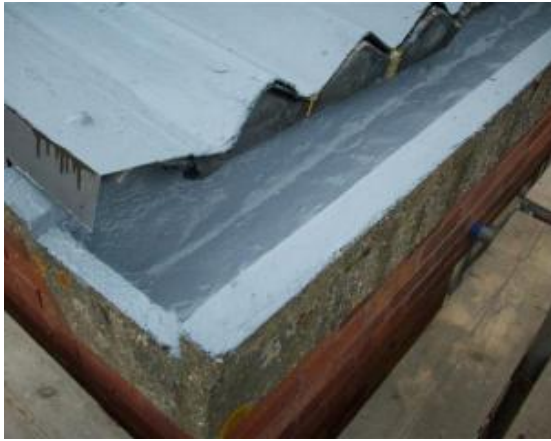
Gutters will generally need to be cleared of all accumulated dirt, debris and any other deleterious material and then washed as part of the surface preparation (HSE guidance note a10). When coating these prepared gutters, particular attention should be paid to the gutter joints as this is the main point of potential leaks. Generally these joints will require additional reinforcement to the liquid coating to accommodate any movement in the joint in line with manufactures specifications.

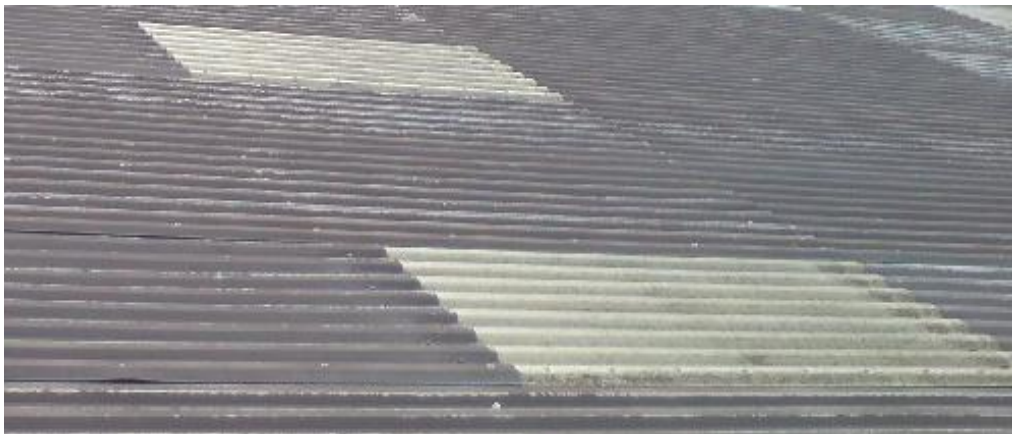
The pattern of the translucent sheets is important when it comes to the decision of what treatment is required. Depending on the individual roof and the manufacturer's specification, if the translucent sheets run from ridge to eaves and if the translucent sheets are in good condition it may be possible to clean the translucent sheets and finish the profiled sheet coating on the down slope of the translucent sheet profile.

If the translucent sheets are laid in a checker board pattern they could be coated with a pigment free coating in order to both maintain the translucent quality of the sheets and also to ensure that the whole roof maintains the seamless feature of a liquid coated roof. Even if the translucent sheets have been replaced consideration should be given to coating the sheets to maintain the continuity of seamless coating. Detailing the joints between inline rooflight panels and the surrounding profiled sheets can be problematic and the individual manufacturer's recommendations should be followed.
