1. Introduction

The coating of profiled sheet roofs in order to extend the waterproofing life of such structures has long been within the realms of the liquid roof waterproofing industry. This Guidance Note highlights some of the issues that need to be taken into consideration when undertaking this type of work.

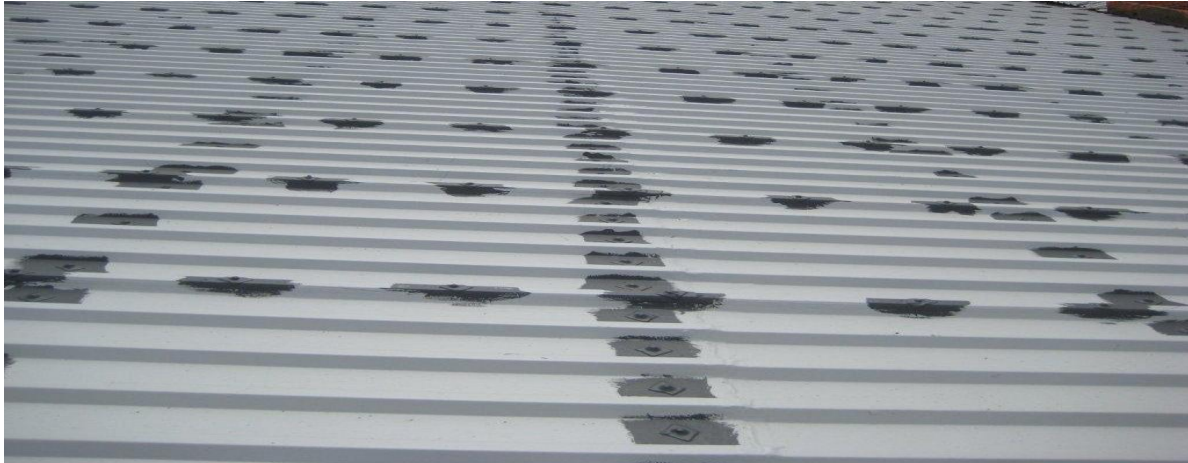
Fixings are probably the main reason for water ingress in this type of roof. Over the years the sealing washers (Rubber, Neoprene etc) will have deteriorated and perished. The fact that some of the washers will have perished will mean that some of the fixings will be loose which in turn will allow water ingress. Many of the fixings will also be affected by rust and will prove difficult to tighten up. All the fixings should be wire brushed and given individual treatment in accordance with the coating manufacturer's specification, this would generally involve the application of a reinforcement which would be bedded in the coating material prior to the application of the full coating specification.

The number of fixings should also be checked. If the fixing spacings are not adequate, flexing of the roof sheets can occur when operatives access the roof for maintenance or during coating. If this occurs it can be extremely difficult to properly detail over the fixings themselves and also side and end lap joints.

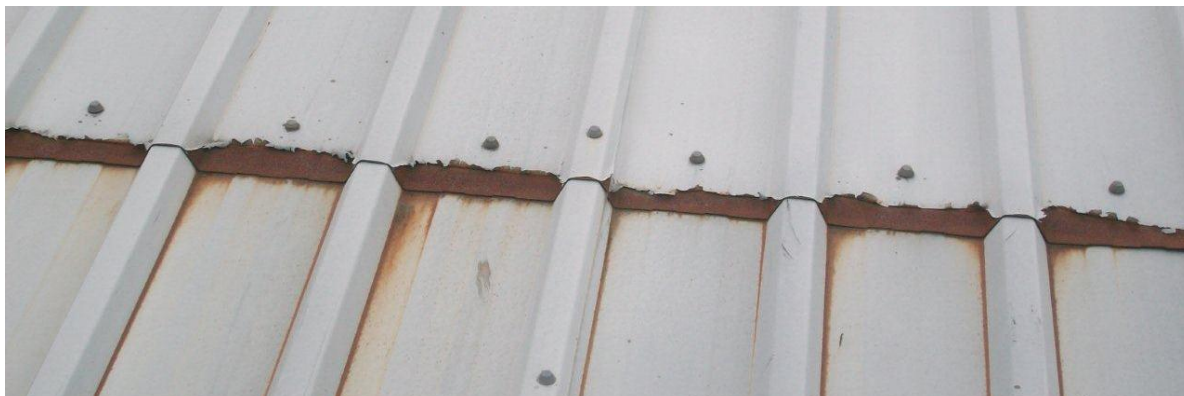
Over the last 20 years, some cut edge corrosion systems have been routinely used on PVC plastisols, including many based on silicone technology. If the repair system used is not breathable, it is possible that condensation will have occurred on the underside of the roof sheets. Liquid can then collect just above the cut edge sealed joint detail and reflux as the sheet heats and cools from direct sunlight. There is then a possibility that corrosion can be promoted from the reverse side of the roof sheet. This is potentially impossible to treat as there is no way of accessing and preparing the sheet reverse side. Tell-tale signs are as follows:

1. Existing cut edge repair is visible but rust staining is weeping from the repairs
2. Corrosion blisters are seen in the sheet above the joint (usually before the first fixing above)
3. In extreme cases, the sheet will be visibly corroded.

The only options for treating this defect is either re-sheeting or removal and replacement of the bottom edge of the profile metal sheeting.

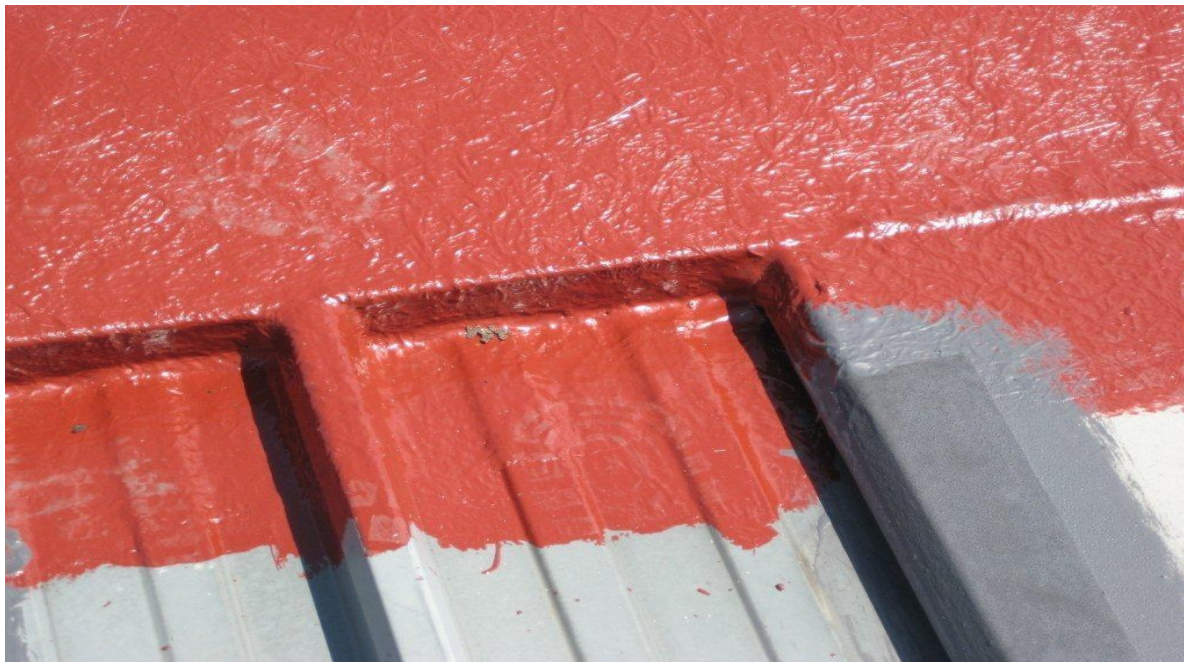
Many profiled sheet roofs suffer from problems that affect the profile filler pieces at ridge and eaves details. They may have either perished, worked loose over the years or have been removed by birds. This allows wind driven rain to blow under the capping and into the structure, eventually showing as water ingress at sheet laps or the gutter area. The other reason for water ingress in this area is that the fashion for low pitched roofs again allows wind driven rain to penetrate the detail once the sealants or filler pieces have passed their useful life. There are two options available when dealing with this problem, either fix a new larger profile ridge capping over the existing ridge flashing (this will also allow for the fixing of new filler pieces) or allow for complete encapsulation of the ridge detail with the coating system specification. This will also probably need some form of gap filling to provide a suitable backing for the liquid coating.

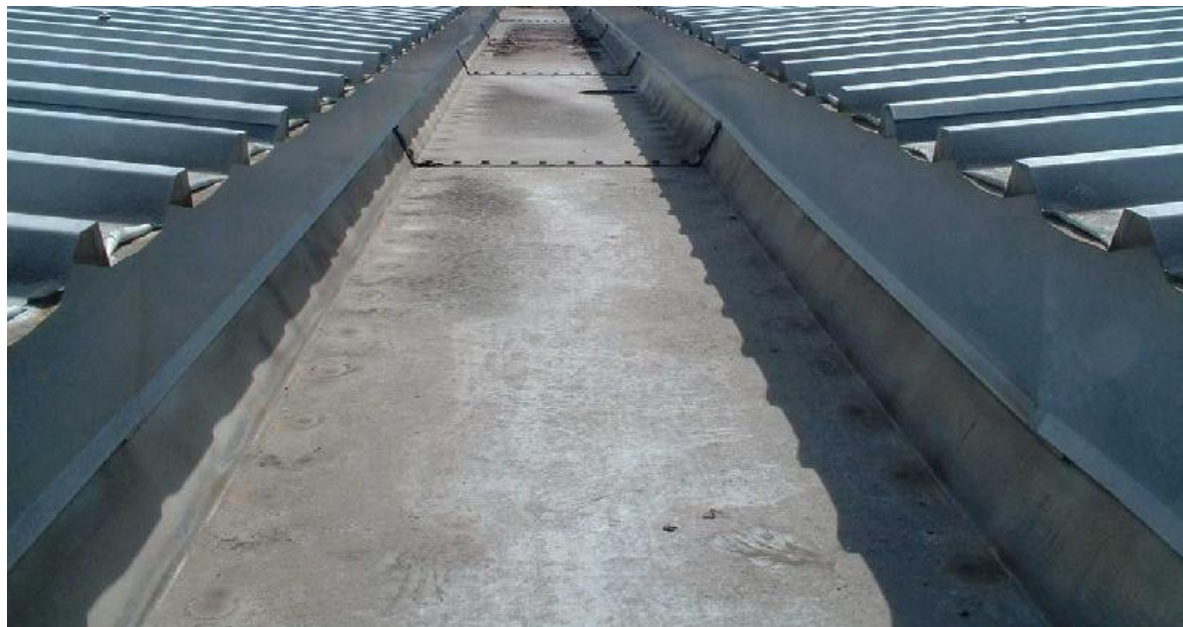
Gutters will generally need to be cleared of all accumulated dirt, debris and any other deleterious material and then power washed as part of the surface preparation. All rust and flaked metal would have to be removed and wire brushed to provide a good clean surface. A rust inhibitor should be applied where necessary prior to the application of a suitable metal primer. All gutter joints need to be treated in accordance with the coating manufacturer's recommendations which generally involve the use of a flexible reinforcement and bond breaks to allow for expansion and movement between the different gutter sections. The waterproofing specification should then be applied to the correct coverage rates recommended by the coating manufacturer. Where possible the gutter should be treated independently from the main roof with the coating material terminating under the profile sheet or under the gutter cover flashing. It is important to note that it is difficult to fully seal the upstand and flashing details in this type of construction. This may lead to water ingress if the gutter were to flood.
